The transmission tub

This is another heavy tub I keep on the bottom shelf. Its got transmission parts.

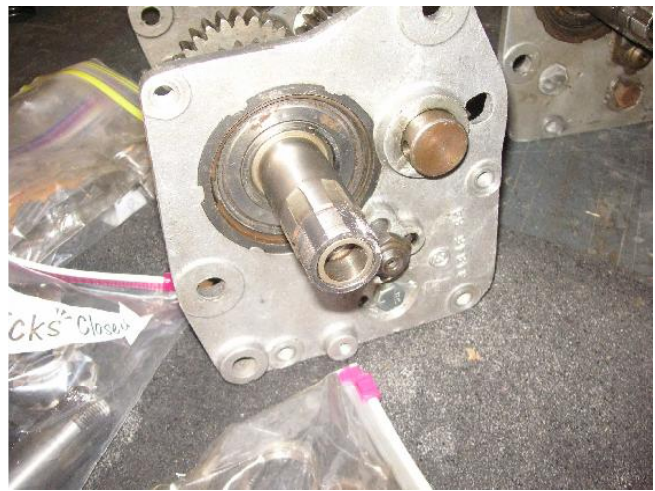
Pretty sweet, three complete transmissions. These are good candidates to be put into my spare cases or maybe just sell them all on eBay.

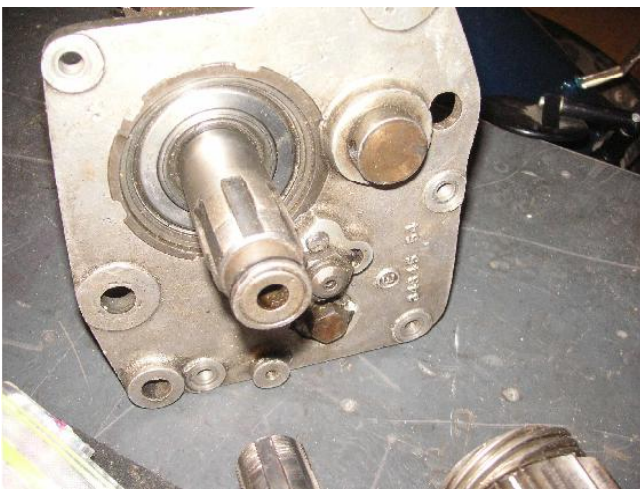
The second trap door also has the threaded boss. On bikes with tin primary, sometime the boss was not drilled and tapped.

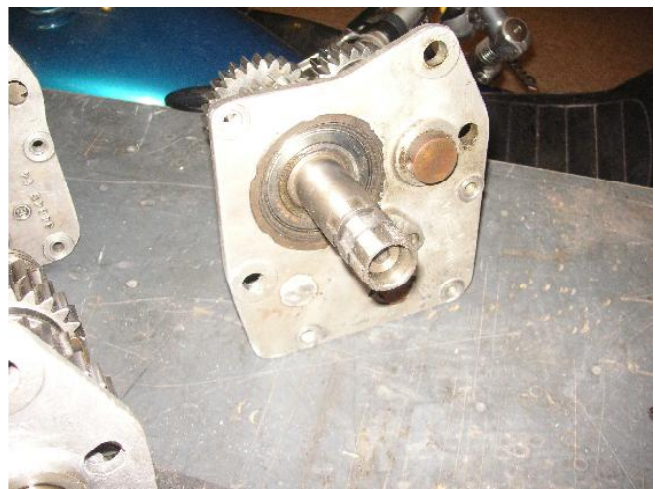
All three trannys are for 1976 and earlier bikes. This one has the threaded boss at the bottom for the primary cover bolt on dry clutch bikes with the early center-mount primary cover.

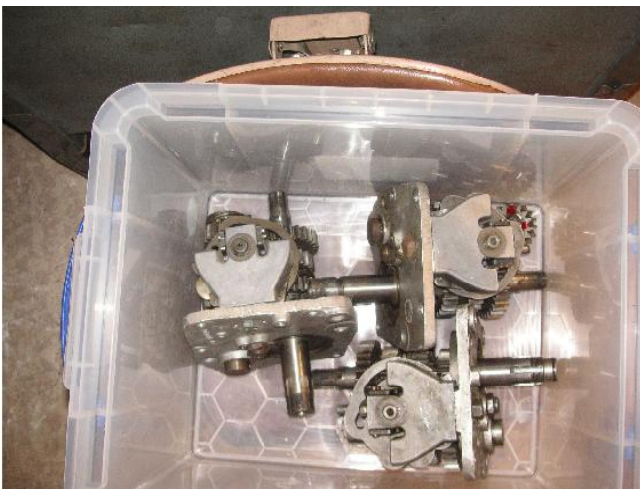
The third tranny trap door is the latter model without the boss. They stopped using [the center-mount primary cover in 1966](#).
