Mainshaft 2nd gear

This gear has been the same since 1956.

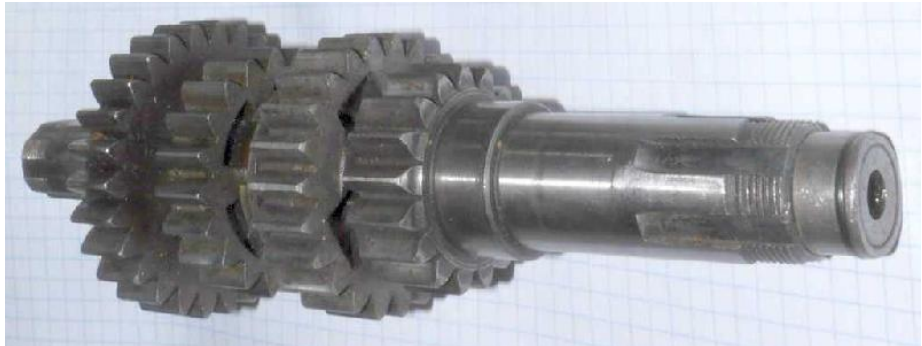
The Iron Sportster mainshaft is a triumph of engineering. The general design has sustained from 1952 to 1984. There were teething problems in the early K-model, but they were all cured by 1957 with the introduction of the Sportster.

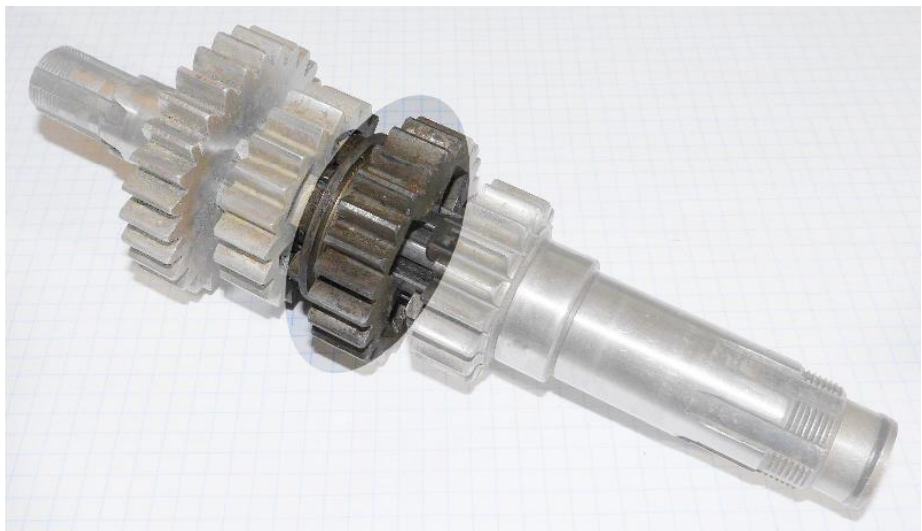
Mainshaft second gear is in the darker oval. Gears are named for carrying power, not the order on the shaft. The gears from left to right are mainshaft low, mainshaft 3rd, mainshaft 2nd, and the clutch gear.

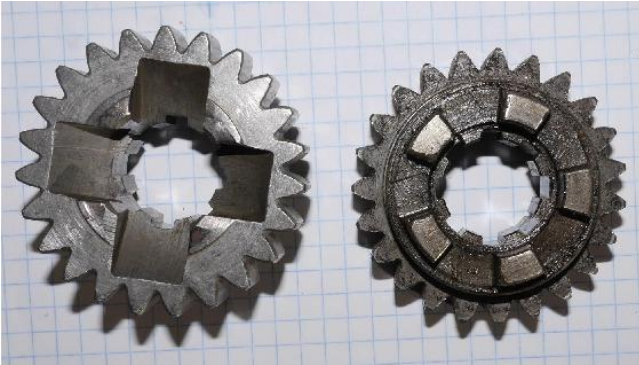
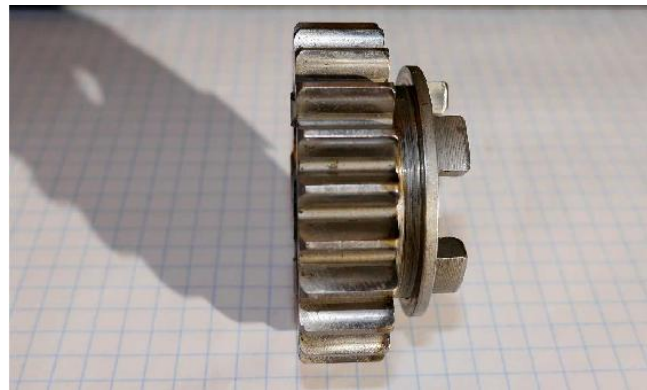
Sportster 35296-56 Mainshaft 2nd-gear,
1956-1978

35296-56

23 teeth, 1956 to 1978

The part changed to a 35296-56A in 1979, which should retrofit with this gear. Letter suffixes usually mean the part is very similar and will replace the part with no letter suffix.
