Shifter plate

The plate has the grooves that move the shift forks as it rotates.

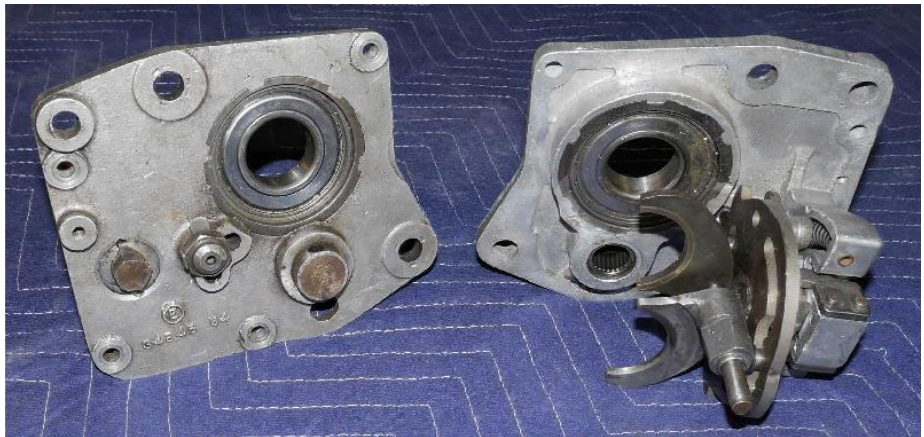
The Iron Sportster trap door assembly holds the mainshaft, countershaft, and shifter mechanism.

This plate, often called a "cow paddy" shifter due to its flat shape moves the shift forks into position as you go through the gears.

Big bikes used a similar system before adopting a barrel cam. Evolution bikes use a barrel cam as well, one that the forks mount on.

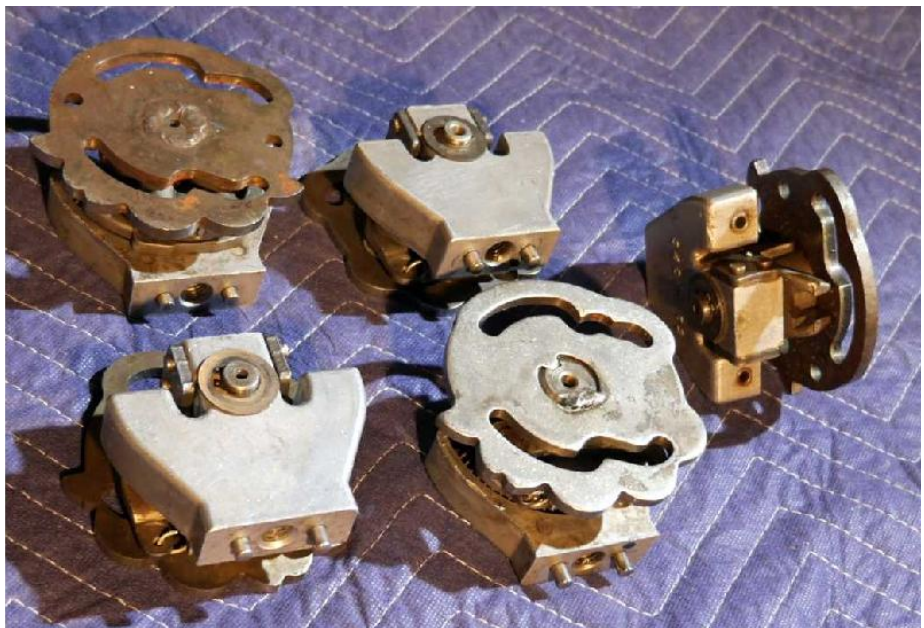
The Iron Sportster shifter comes as the 34009-52 assembly.

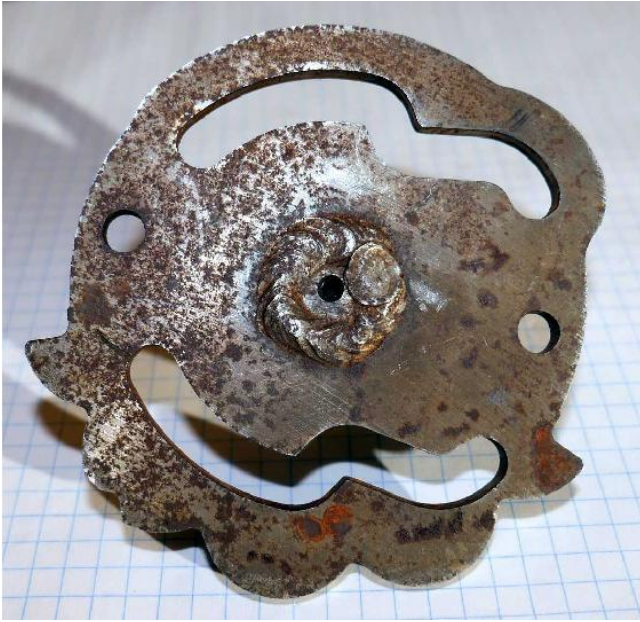
34012-52

The early plate has two located holes probably used during manufacturing. The weld of the plate to the shaft is uniform and circles the entire shaft.

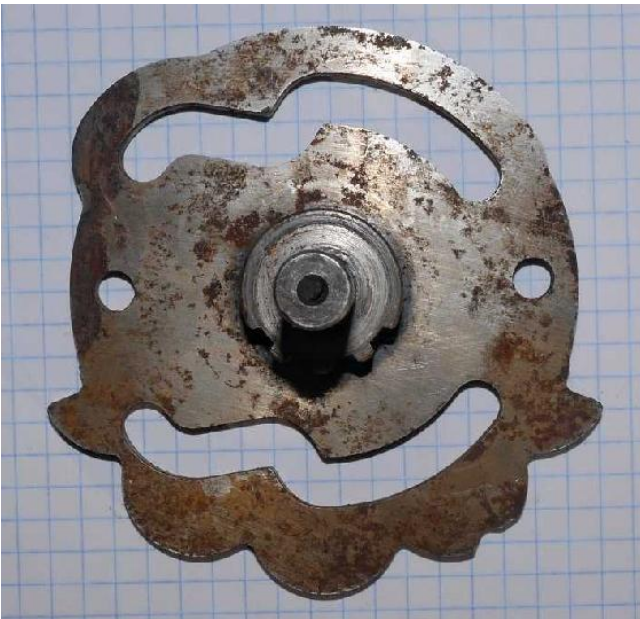
The boss in on the shaft is continuous and there are two "ears" where the detent cam runs. Here detents are 4th, 3rd, 2nd, neutral and 1st from left to right.

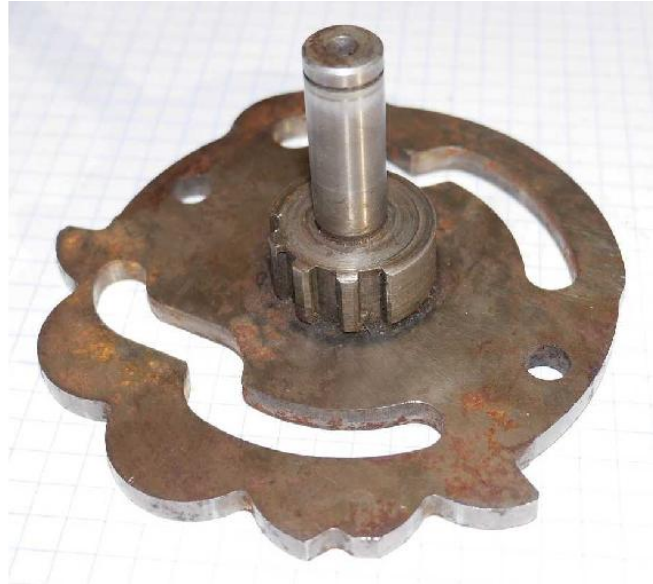
34012-52 (cont)

A better view of the ratchet dogs that get yanked on my the shifter pawls. Similar to a spline, but with a unique profile to suit the pawl's engagement.

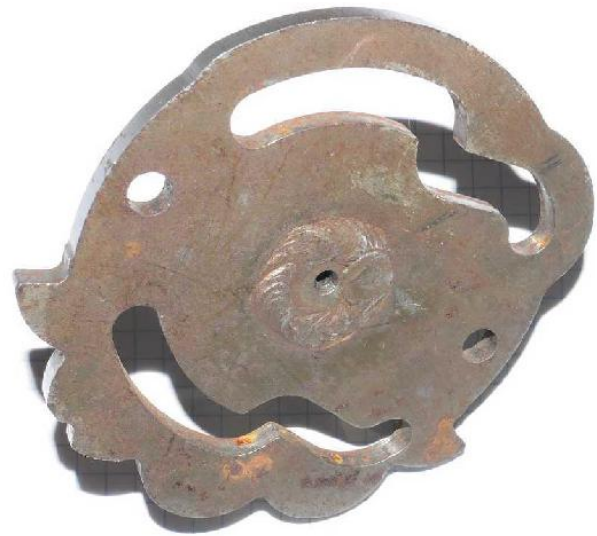
A 3/4 view shows the diligent welding and the sharp edges of this early shifter cam plate.

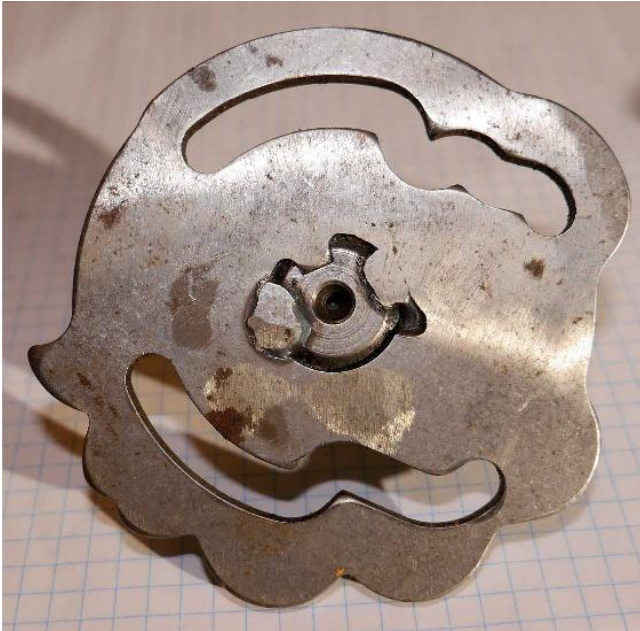
34012-52C

The -52C plate is cost-reduced, being made from a single press blanking operation. Note the rounded edges compared to the early plate. The full-circumference weld is replaced by two tack-welds. One of the "ears" disappears, not sure why.

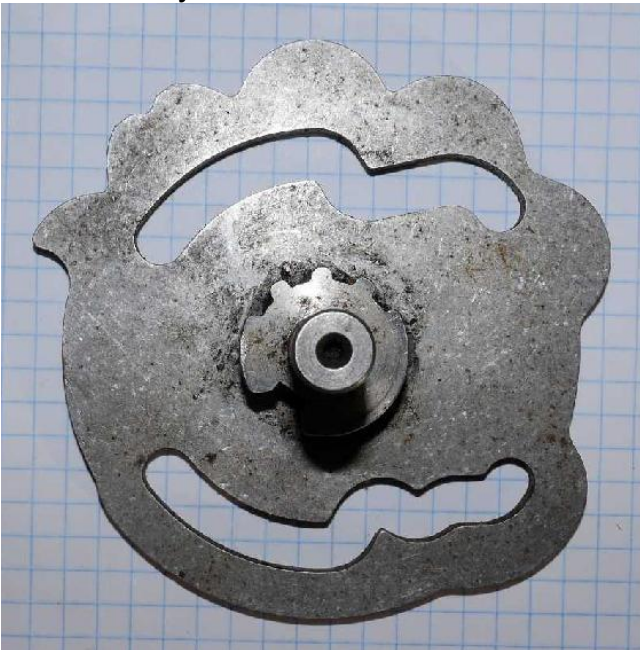
Backside shows shaft has a chunk missing.

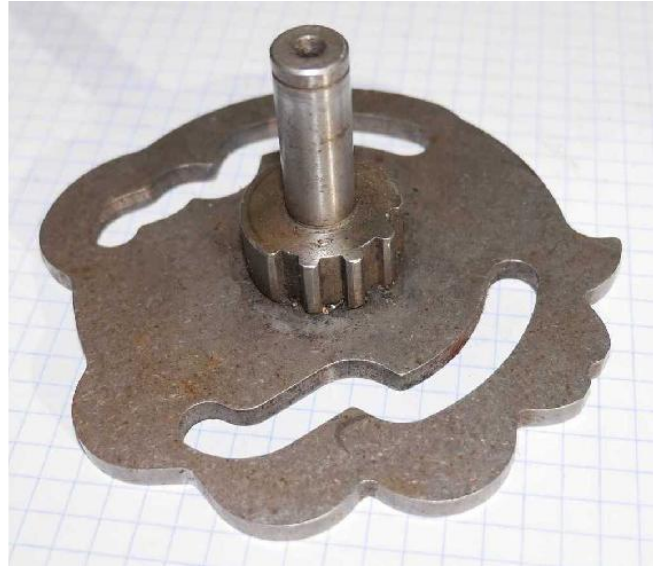
34012-52C (cont)

A better view of the ratchet dogs. They appear equivalent to the earlier dogs. The "C" letter suffix in the -52C implies this plate will retrofit with the earlier plate.

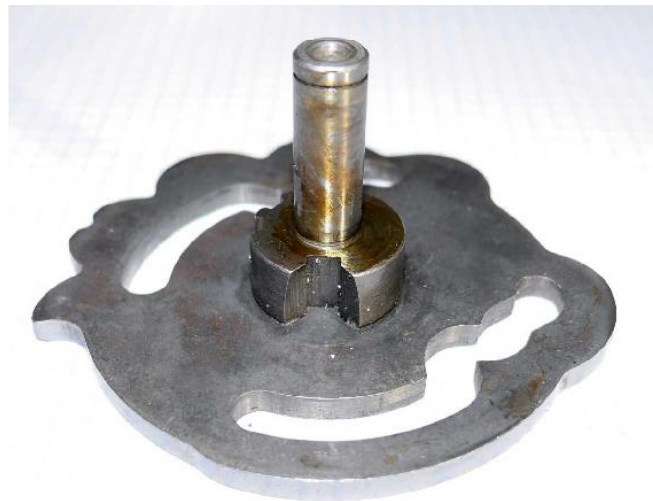
The -52C plates have a big chunk missing from the shaft collar. This may be a function of the upsetting or forging operation, it is hard to believe Harley engineers were just trying to save a few pennies of steel. Its a puzzlement.

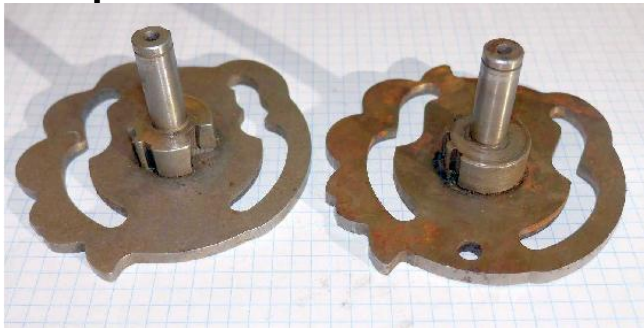
Comparison views

The earlier version on the right has sharper edges, and no chunk missing from the shaft collar. Later part also lacks the two locating holes.

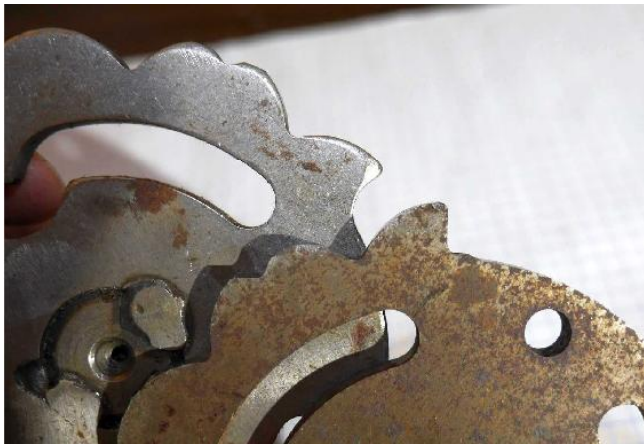
This view highlights the sharper edges on the earlier part on the right. Either the earlier part was done with wire EDM (electrical-discharge machining) or post-machined, or fine-blanked, which is hard to believe for such a thick part.
