# Trap door

**The trap door has been very similar from 1954 to 1984.**

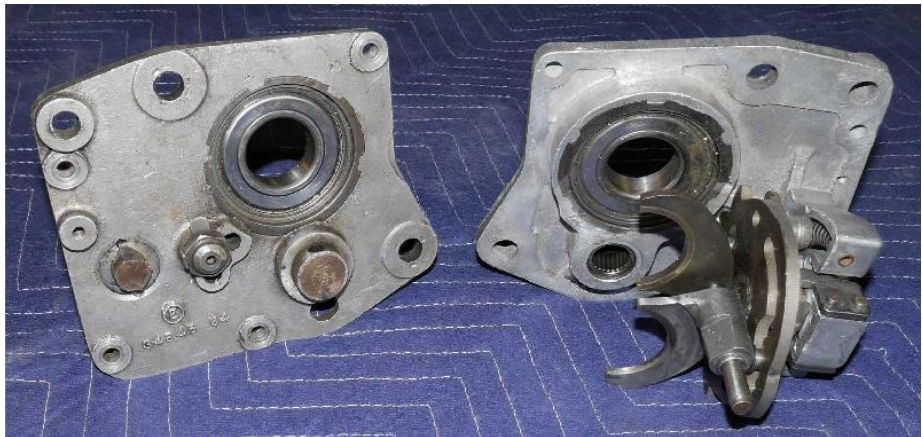
The Iron Sportster trap door assembly holds the mainshaft, countershaft, and shifter mechanism.

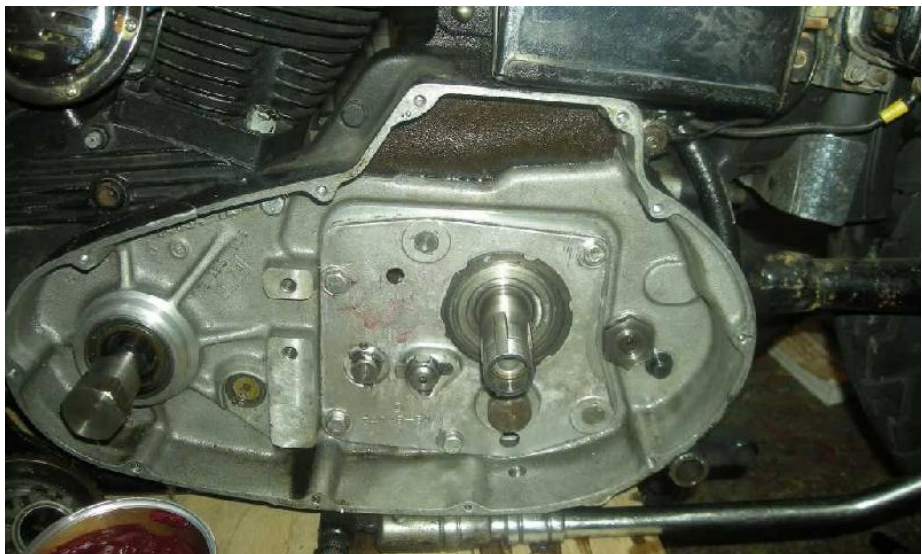
The trap door is held in with 4 5/16 course-thread bolts on the left side of the engine. (courtesy scottericsonon)

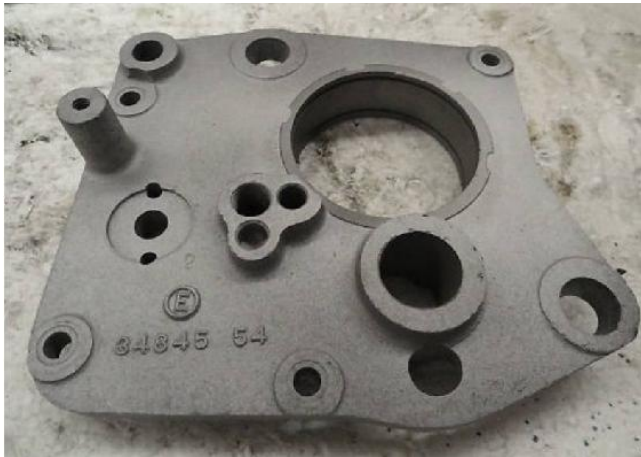
1954-1956 K-models

The 1952 and 1953 K-models did not have a trap door. You have to split the cases to service the tranny. The 1954 door is similar to the -57 door but the dowel holes are tapered, instead of straight. The boss to mount the primary cover sticks out much further.

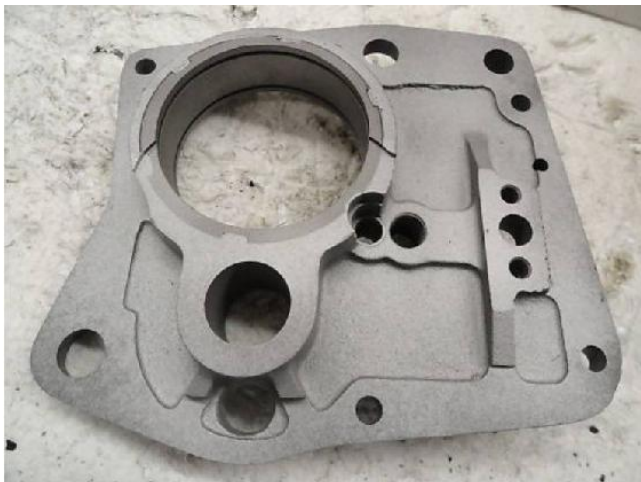
The backside of the trap door is where the shifter mechanism, as well as the shifter forks, and the gear shafts. Harley engineers must have considered this door part of the left case, hence no part number was cut.

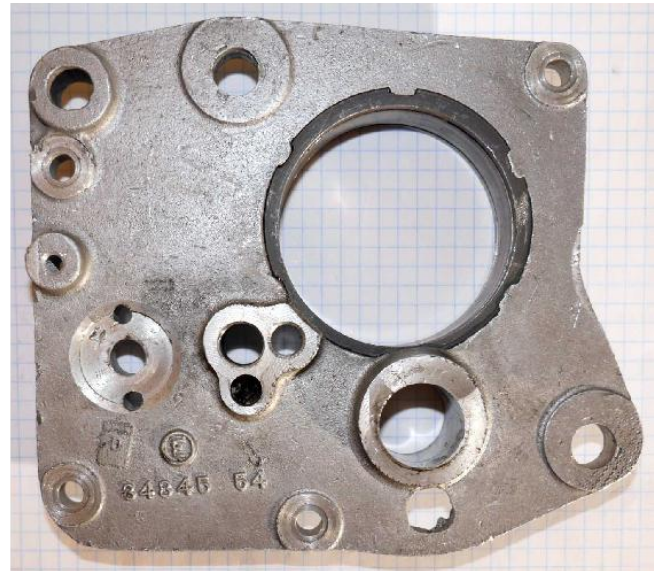
1957-1976 all, but with variations

The same 34845-54 casting number as the K-model door, but a different casting at the primary boss mount.

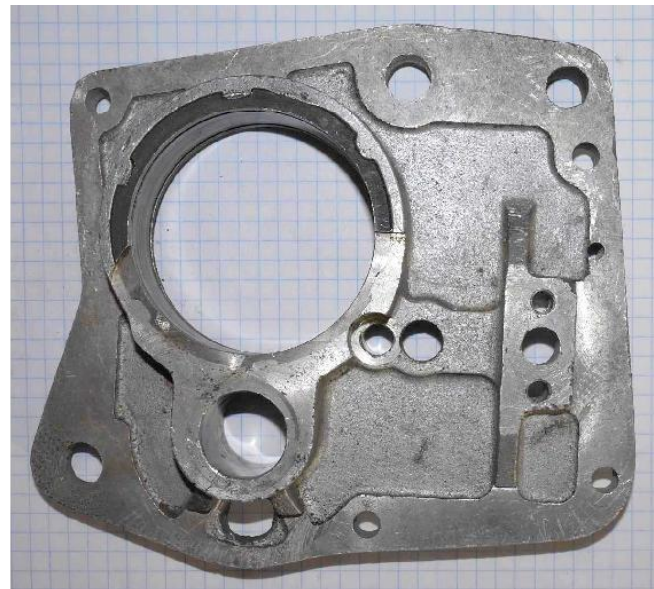
The door is machined for straight dowel pins, otherwise similar to the K-model door. Shorter boss for mounting the primary cover. Shorter boss would allow more parts to fit in a box, but would also strip out easier.

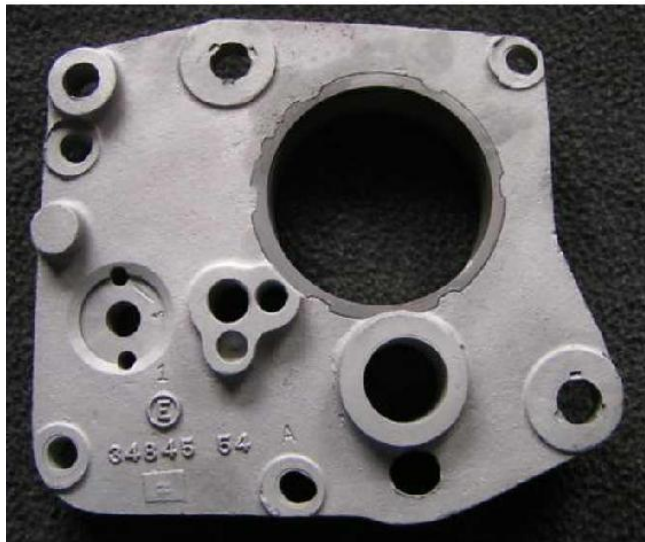
**34844-57 variation 1**

The same 34845-54 casting number which seems correct. The 1/4-20 hole for the primary cover is not drilled. This may have been used on XLCH models that don't use the center-mount primary cover.

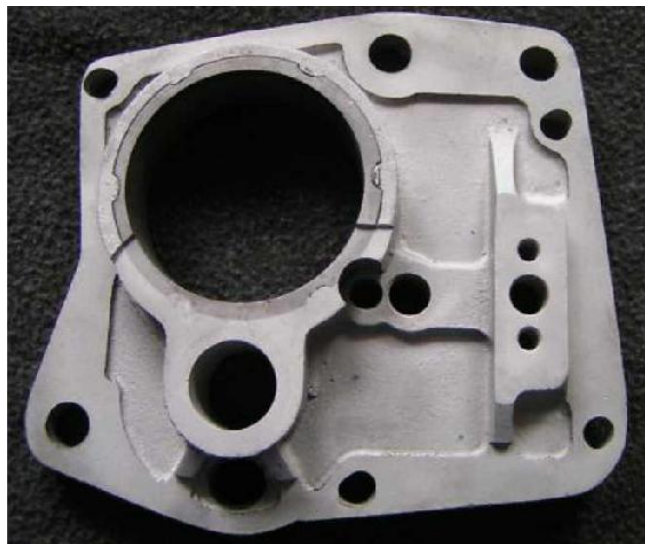
The backside seems identical, other than the small hole in the right edge where the tapped hole usually is.

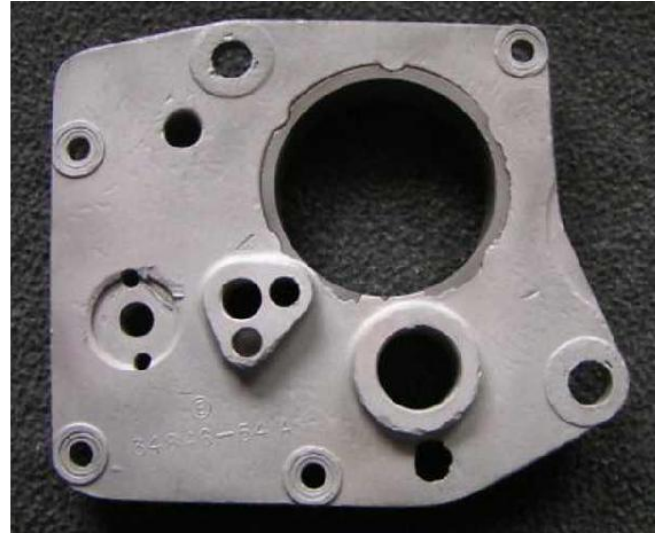
**34844-57 variation 2**

Here the factory bumped the casting number to 34846-54A and removed the boss for the primary cover mount completely. No record of a service part number, this may be a -57A but that number does not appear in the parts books, it is just supposition.

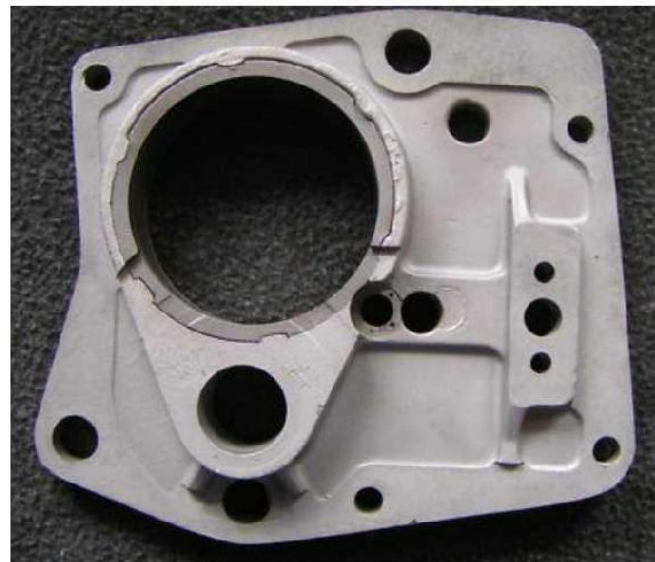
The new casting has much more material between the mainshaft and countershaft bearings. Not the added hole below the top dowel pin hole.

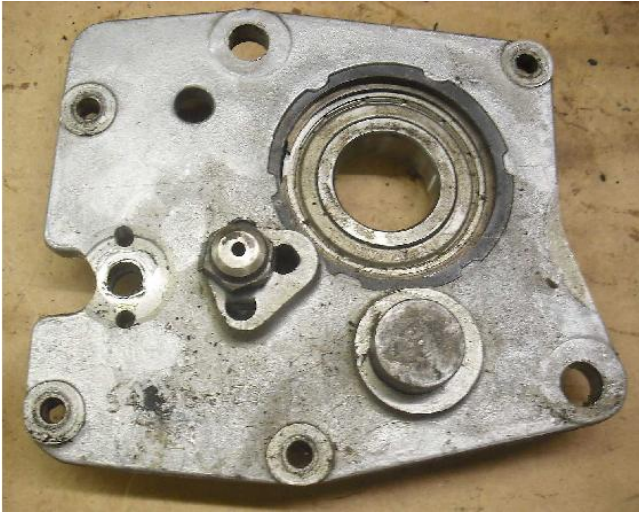
**34844-57B**

Casting number 34846-76. This door has a big divot in the left edge to pass the shifter shaft, on the left side starting in 1977. It was part of the major case redesign financed by the AMF (American Machine and Foundry) owners of Harley Davidson.

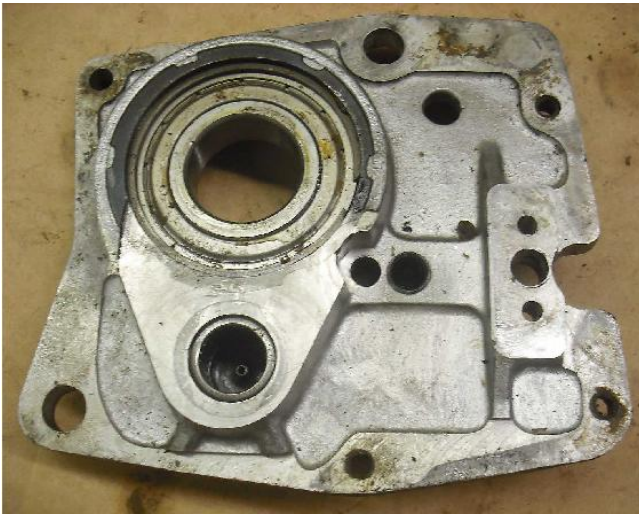
Like the mystery door just prior, this door has much more material between the mainshaft and countershaft bearing holes.

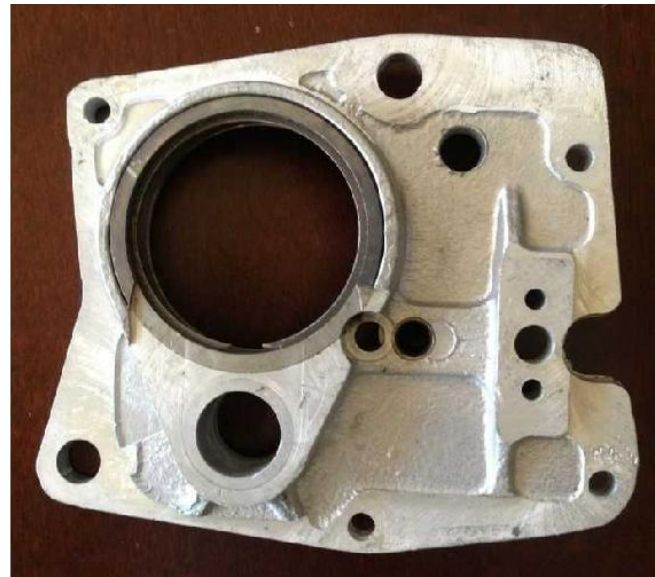
The increased material between the shaft bearings is a good feature of this part, and why you might want to retrofit it to any 1957 or later bike that does not need the center hole primary cover mount.

You should line-hone the mainshaft bearing in the case any time you replace a trap door.

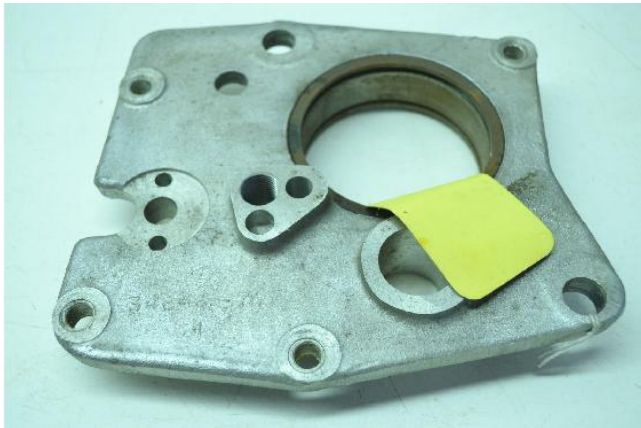
**34847-79**

Casting number 34846-76. I think the snap rings in the bearing bore are wider in the 79-later tranny, otherwise identical.

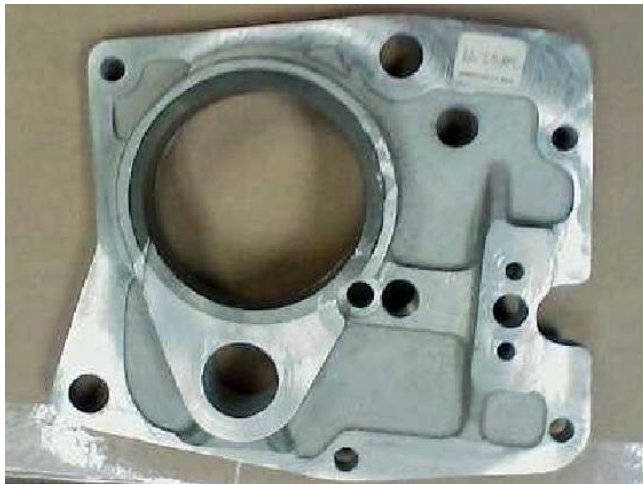
The wider snap rings may keep the mainshaft bearing from moving a little to the right side when the clutch is depressed. This closes up the mainshaft endplay, unlike dry clutch setups where the clearance increases with clutch application.

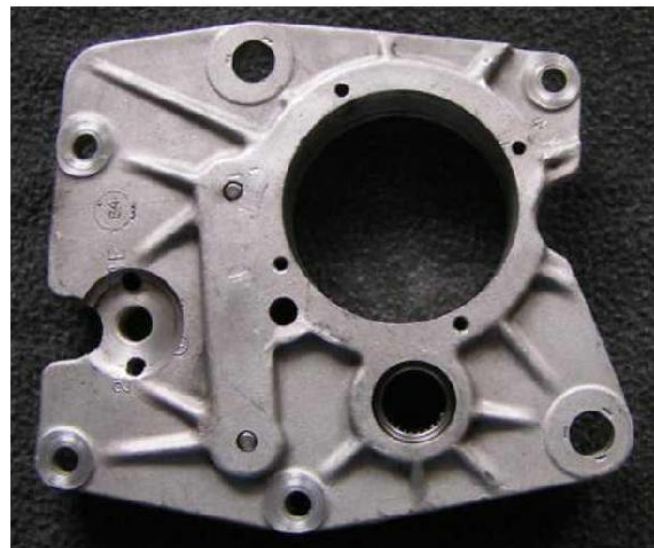
**Goof ball**

In late 1984 the factory decided to remove the easily-serviceable generator from the front of the engine. They put an alternator behind the clutch.

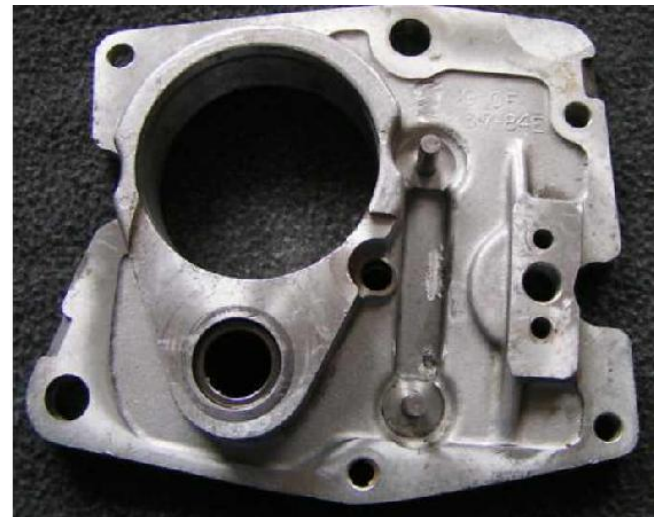
This is so different from any other Iron Sportster this late 1984 model is not covered in this website. In 1985 the Evo Porsche engine was introduced. This alternator setup did not last long, Harley soon moved the alternator under the front sprocket, like on Big Bikes since 1970.

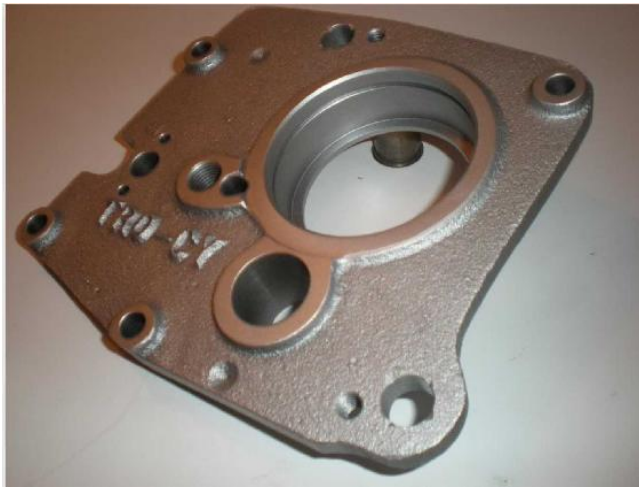
## Trock

Ron Trock served the drag racing community. To make the strongest trap door he could, he used cast iron.

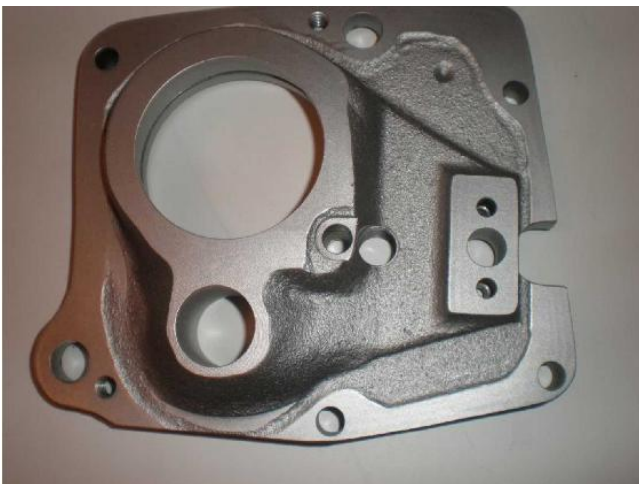
The downside to the strength is that this door is much heavier. There are modern aluminum alloys that are nearly as strong, at least in their billet form.

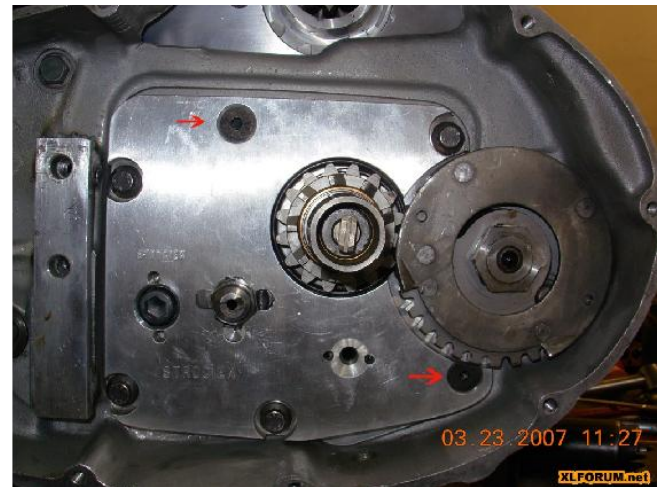
## Stociek

David Stociek was a drag racer in the midwest. He offered this billet trap door. It may still be available. (courtesy fdny37)

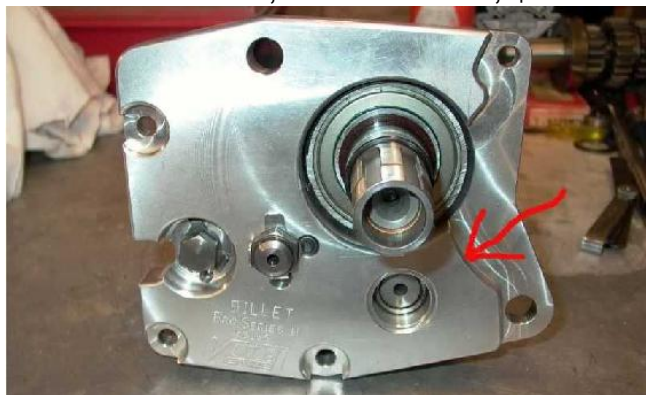
## Vulcan

Fit problems, (courtesy ericfreeman55)
